**Flood Control Project Maintenance
Levee Inspections**

Maintenance Issue Types Only, Levee Inspection Report By Mile - Spring 2016

Sutter Maintenance Yard Hamilton Bend

Waterway	Bank	Unit Miles	Inspection Start/End	Inspector
Unit No. 01 Feather River Hamilton Bend	Right	3.39	04/05/2016 04/08/2016	Sterling York

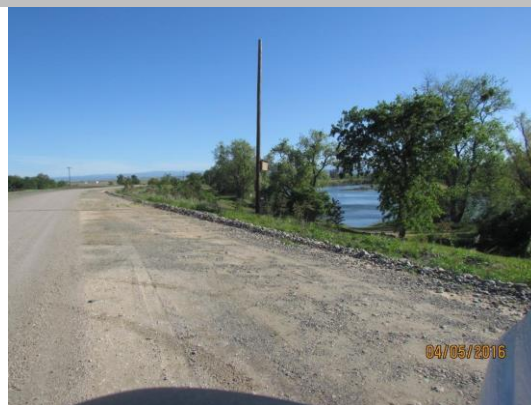
Photo 1 of 1 : SP_2016_ST0005_289_14_20160418_00027.jpg

LM Start	0.73	Rating **	M	Issue No.	14
LM End	0.91	Issue Type +	Ma	Location *	WS
Category	Earthen Levee			GPS Latitude/Longitude	
				Start	End
Item	Trim / Thin Trees			39.450109 °	39.452643 °
				-121.640851 °	-121.640316 °
DWR ID	DWR_ST0005_01_s_2016_14				
Comment Code					
T3 : Trim and thin trees to allow visibility of the ground and room to flood fight.					
Inspector Comment					
trees smaller than 4" in diameter at chest height should be removed before they get any bigger.

View looking upstream of trees. Small trees 4" in diameter at chest height should be removed before they get to big., Spring 2016.

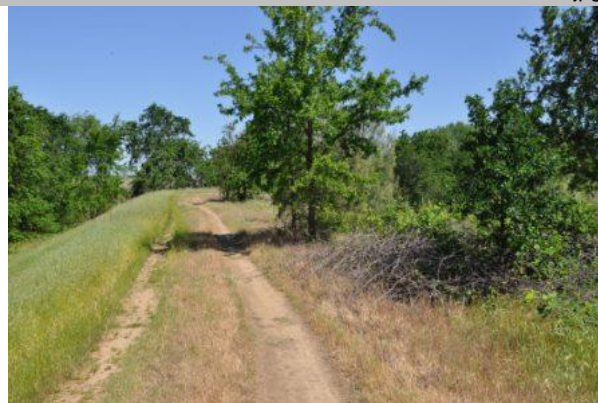
Photo 1 of 1 : SP_2016_ST0005_289_5_20160307_00003.jpg

LM Start	1.69	Rating **	M	Issue No.	5
LM End	3.04	Issue Type +	Ma	Location *	WS
Category	Earthen Levee			GPS Latitude/Longitude	
				Start	End
Item	Trim / Thin Trees			39.459451 °	39.469081 °
				-121.633670 °	-121.612535 °
DWR ID	DWR_ST0005_01_s_2013_5				
Comment Code					
T3 : Trim and thin trees to allow visibility of the ground and room to flood fight.					
Inspector Comment					
Trees smaller than 4" in diameter at chest height should be removed before they get any bigger.

W/S trees 4" in diameter at chest height should be removed before they get to big..

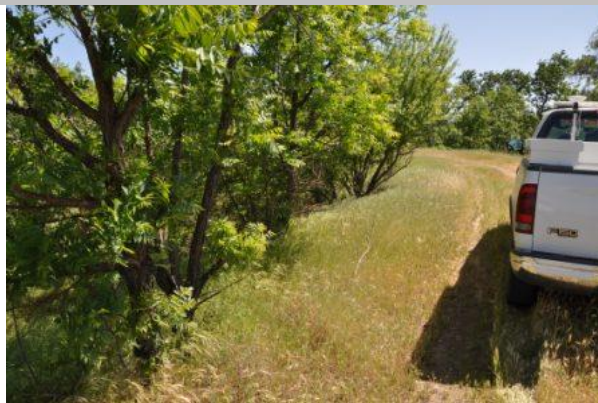
Photo 1 of 1 : SP_2016_ST0005_289_4_20160307_00002.jpg

LM Start	3.26	Rating **	M	Issue No.	4
LM End	3.27	Issue Type +	Ma	Location *	LS
Category	Earthen Levee			GPS Latitude/Longitude	
				Start	End
Item	Trim / Thin Trees			39.470433 °	39.470558 °
				-121.609200 °	-121.609215 °
DWR ID	DWR_ST0005_01_s_2013_4				
Comment Code					
T3 : Trim and thin trees to allow visibility of the ground and room to flood fight.					
Inspector Comment					
Small trees 4" in diameter at chest height should be removed before they get to big.

L/S trees. Small trees 4" in diameter at chest height should be removed before they get to big.
